# INVENTORY FORM FOR STATE HISTORIC SITES SURVEY

1 NAME				
HISTORIC	WORKMAN FARM			
AND/OR COMMON				
2 LOCATIO	N East side of Rejunction with	oute 29 <b>4,</b> ½ mile sou Route 298	th of	
CITY, TOWN	Wantan		CONGRESSIONAL DISTRI	СТ
STATE	Worton	VICINITY OF	COUNTY	
	Maryland			
3 CLASSIFI	CATION			
CATEGORY DISTRICT  X BUILDING(S) STRUCTURE SITE OBJECT	OWNERSHIP  XPUBLIC PRIVATE BOTH  PUBLIC ACQUISIT IN PROCESS BEING CONSIDERED	STATUS  SOCCUPIED  UNOCCUPIED  WORK IN PROGRESS  ACCESSIBLE  YES: RESTRICTED  YES: UNRESTRICTED  XNO	PRESI AGRICULTURE COMMERCIAL EDUCATIONAL ENTERTAINMENT GOVERNMENT INDUSTRIAL MILITARY	ENT USE  _MUSEUM _PARK  XPRIVATE RESIDENCE _RELIGIOUS _SCIENTIFIC _TRANSPORTATION _OTHER:
4 OWNER O	OF PROPERTY			
NAME Ralph	L. Workman		Telephone #: 609	9-429-4930
STREET & NUMBER	E. Marlton Pike			
city, town Cherr	y Hill	VICINITY OF	New Jersey 080	ip code 034
5 LOCATIO	N OF LEGAL DES	SCRIPTION	Liber #: EHP 37	
COURTHOUSE. REGISTRY OF DEED	OS,ETC. Kent County	Court House	Folio #: 756

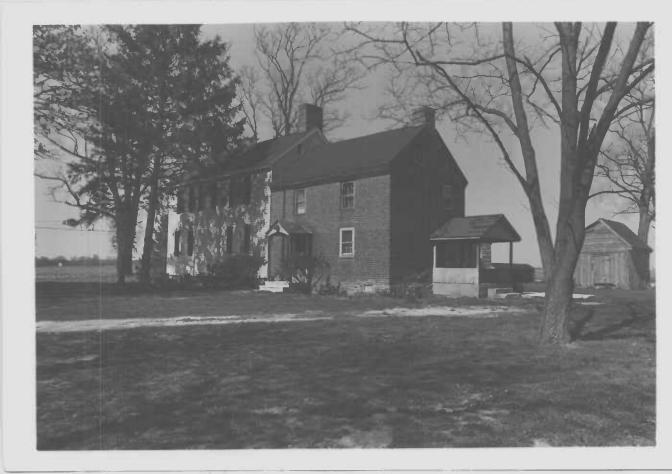
K-223 Workman Farm View to North M.L. Fritz

The house is composed of two sections, a three bay, two story frame section and a two bay two story gable roofed kitchen on the east gable.

The roof is a gable of moderate pitch; it has no dormers. Windows are regularly spaced and have 6 over 6 sash. They retain early louvered shutters hung on small strap hinges set on driven pintels. The rails and stiles of the shutters are quite wide and all finished on the inside edge with a bead. First floor shutters have a single panel of louvering; those on the second have double panels.

Recently the frame section was covered with vinyl siding. The cornice, verge board, trim, and the entire entry door on the southwest facade was covered with siding.

The brick section also has a shallow gable roof without dormers. Instead of a wooden cornice, three steps of corbelling is used at the cornice line. There is an entry in the northern bay of the front and a shed-roofed extension on the northeast wall. A door has been cut into the east gable. Windows have 6 over 6 sash but are shorter than those in the frame section. Frames and sills are plain.

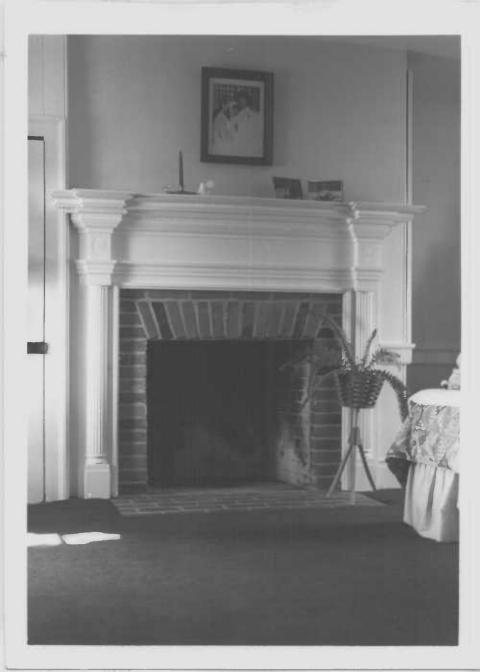
K-273 Workman Farm Hall Mantel M.L. Fritz 7/1980

The mantle in the parlour has a rectangular opening flanked by reeded pilasters. There is a curved mantle shelf which is supported by moldings with dentils and carved sunbursts above the pilasters. There is a closet with a beaded door to the left of the mantle and a six panel door on the stair.

Although appearing to be a small simple farmhouse from the exterior, the Workman Farm contains some of the best late Federal woodwork in the county. The mantle in the hall is particularly beautiful, both in its overall propartions and in the execution of its details. Virtually all of the woodwork and doors in the frame section remain, as does some hardware and the exterior shutters and hardware. The kitchen wing, although its interior has been extensively remodeled, is an early and compatible addition to the frame section.
